MITCHELL'S PASS HISTORIC PRECINCT

CONSERVATION MANAGEMENT PLAN

VOL 1

Final
Revised 9 January 2008

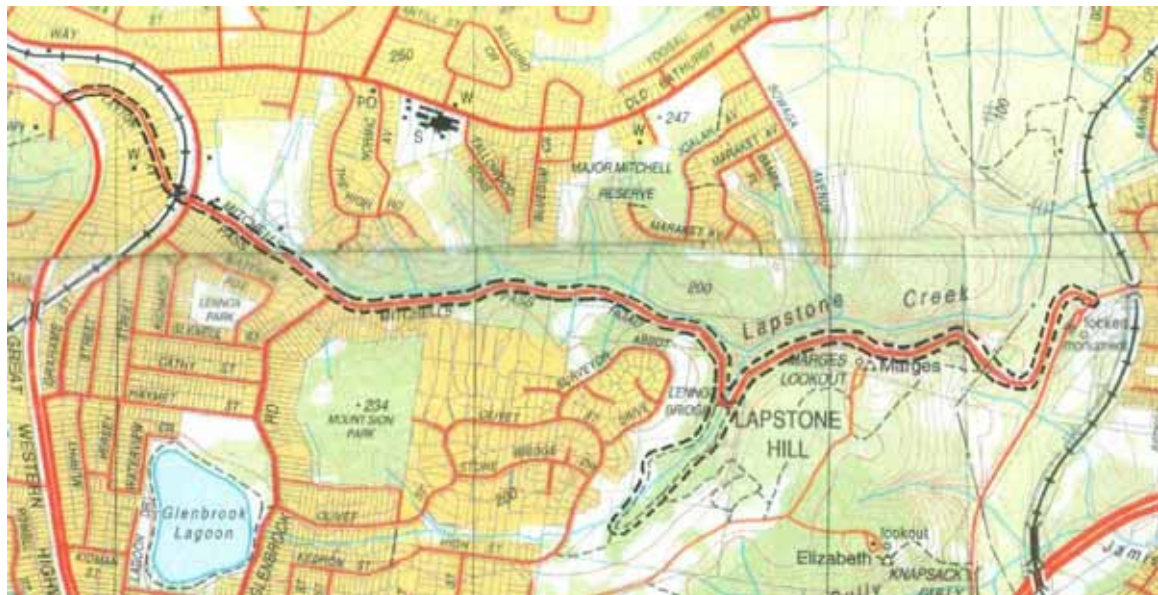
Figure 49

Curtilage of Mitchell's Pass Historic Precinct shown with a heavy dotted black line.

Mitchell's Pass Historic Precinct includes the roadway and associated structure of Mitchell's Pass, Lennox Bridge, the 1832 Bridle Trail and the small quarry. The extent of the place should be as indicated in the map at Figure 49.

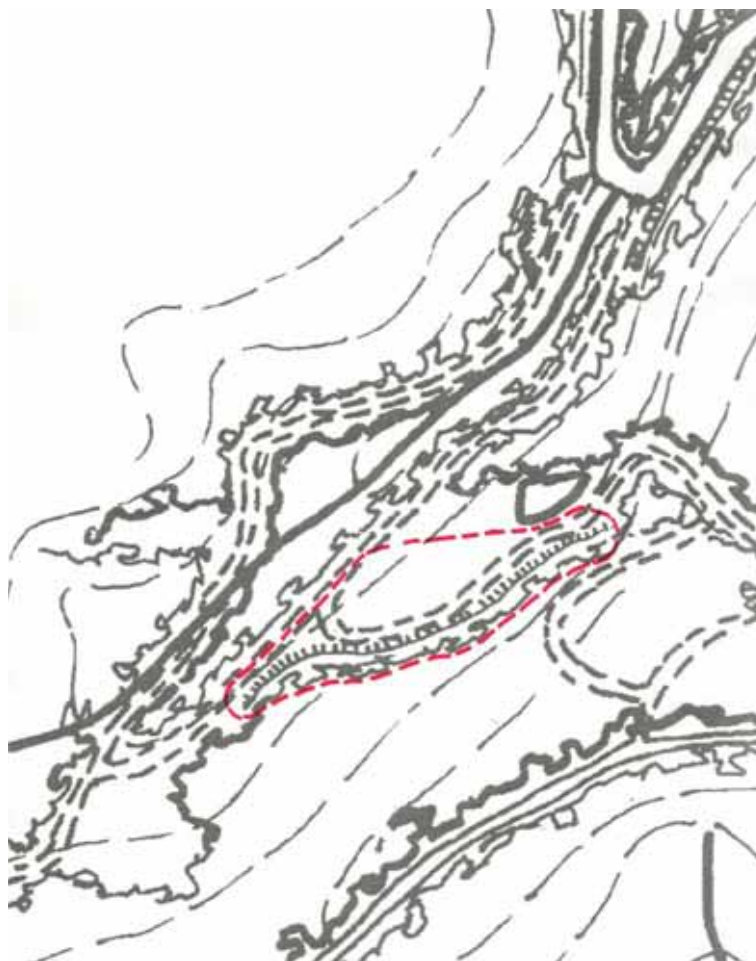
Figure 50
Curtilage of Brookside Creek Quarry (shown by dotted red line).

The quarry on the east side of the 1832 bridle trail should be known as Brookside Creek Quarry. The extent of Brookside Creek Quarry should be as indicated on the map at Figure 50.

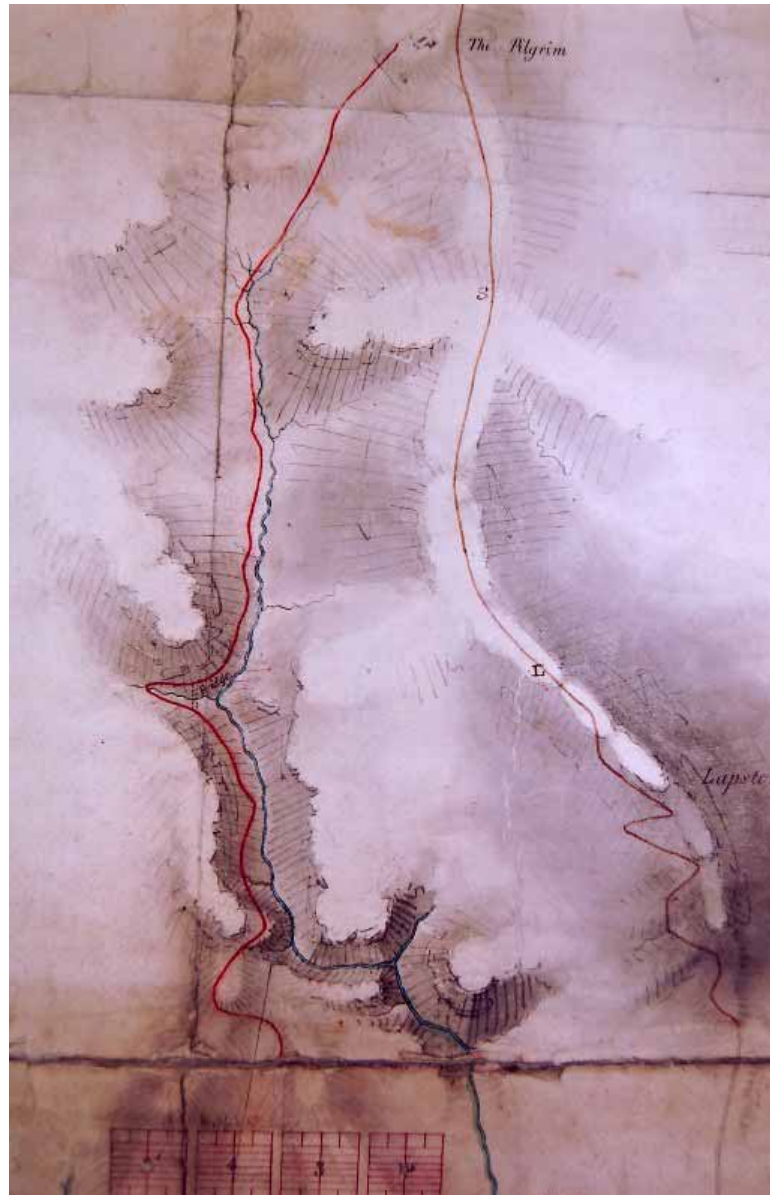
Figure 3

H.F. White's map of Mitchell's proposed line of road to the left and Dumaresq's 1826 road (now known as Old Bathurst Road) to the right, 20 May 1832. Roads are shown in red. The blue line running from west to east (i.e. down the page) is Lapstone Creek. The westerly part of the grid-plan of Emu Plains is at the bottom. North is to the right.

A protracted quarrel with Governor Darling, who tried to separate road construction from the Surveyor-General's responsibilities, diverted Mitchell's attention for a while,¹² but in May 1832 H.F. White, an assistant surveyor, completed a survey and plan of the new line of road which Mitchell had selected in 1830 (Figure 3).¹³

At the west end of the new road, the alignment planned in 1832 and shown on H.F. White's map (Figure 12) seems to have been changed as the road was completed. The original plan was for the new road to skirt the cluster of house and outbuildings known as The Pilgrim or The Pilgrim Inn on its southern side: the front of the inn faced north. The line of road in White's map in fact stops within the south-east part of a fenced area just east of the inn.⁶⁵

Abbott therefore made a new survey early in 1833 (Figure 13). His map shows the projected line of road going through the middle of Wood's large paddock 3, which Abbott describes as "all thick scrub and scarcely a Yard". It then crosses the south-east corner of paddock 1, which is "cleared, stumped and cultivated".⁶⁷ If the road were continued in a straight line, it would, as in White's map (Figure 12), pass The Pilgrim Inn at the rear.

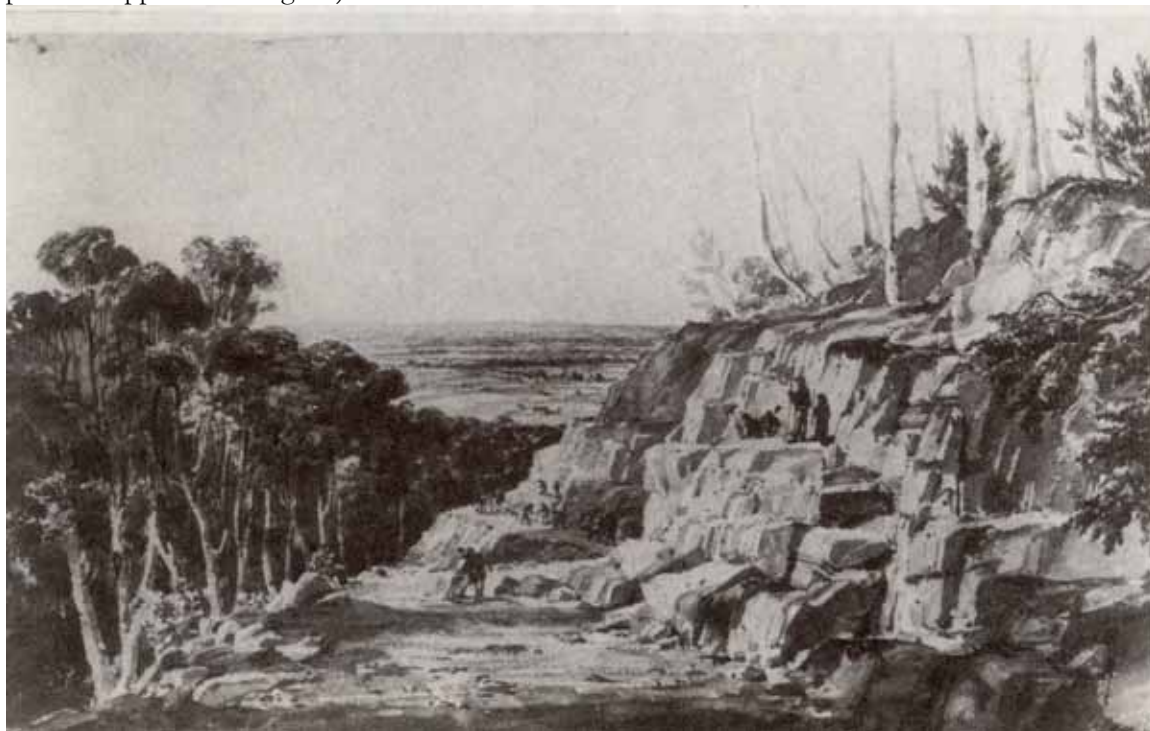
Figure 6

The convict gang at work on Mitchell's Pass below the bridge.

Work on widening the bridle track went hand in hand with Lennox's bridge-building. The shaped stone used for the main section of the bridge had to be supplemented with rubble stone, which was a by-product of the removal of rock on the ascent from Emu Plains. A fine sketch by the convict artist, Charles Rodius, shows work continuing on rock-cutting for widening the road in 1833 (Figure 6).

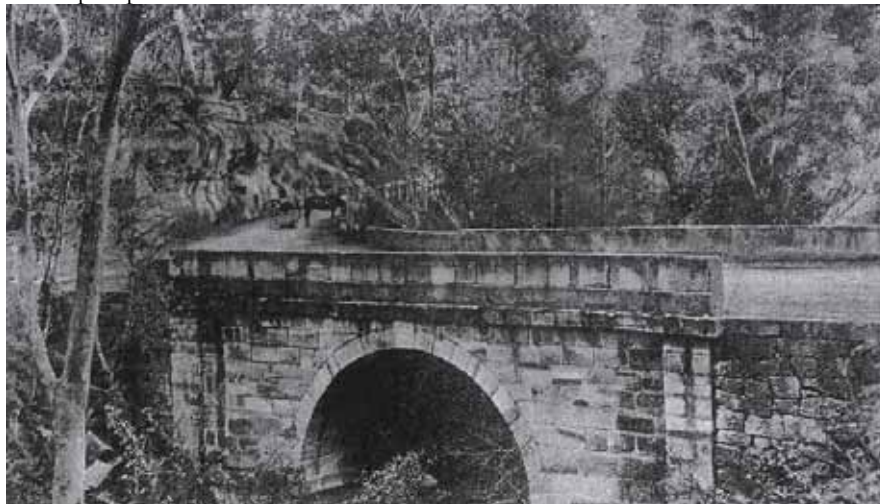
Figure 17
Lennox Bridge from the south-east, in 1905 or earlier.
Source: Mitchell Library, Small Picture File.

These upright stones, so evident in 1880, had disappeared by 1905. A photograph of the south side of the bridge (Figure 17) appears on a postcard which was franked in 1905 and shows no such stones flanking the main parapet.

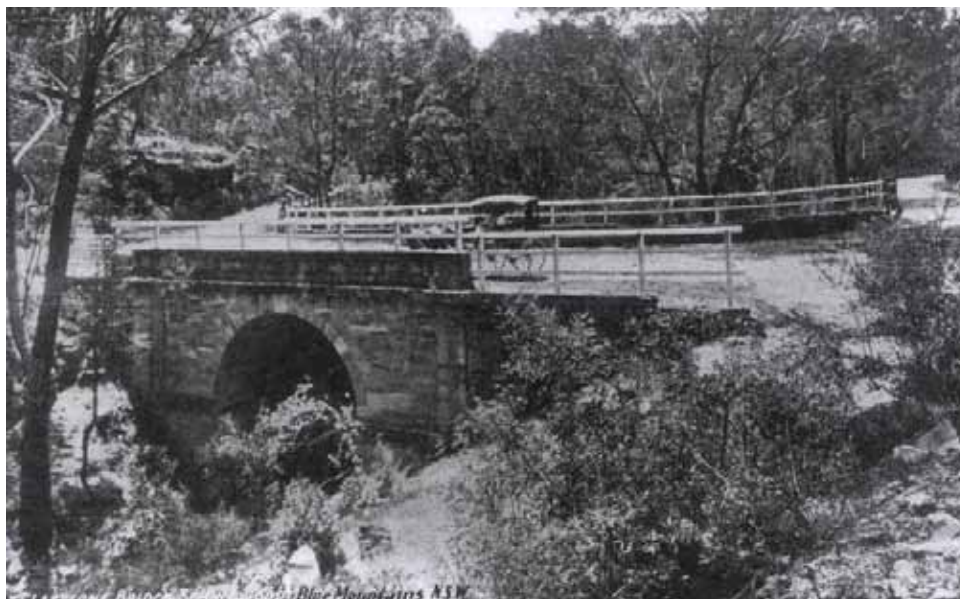
Figure 18

Lennox Bridge from the south-east, soon after 1905 .

Another photograph (Figure 18), showing a small buggy on the bridge, which has now got protective wooden railings both beside and on top of the parapet, is likely to be only a year or two later than Figure 17.

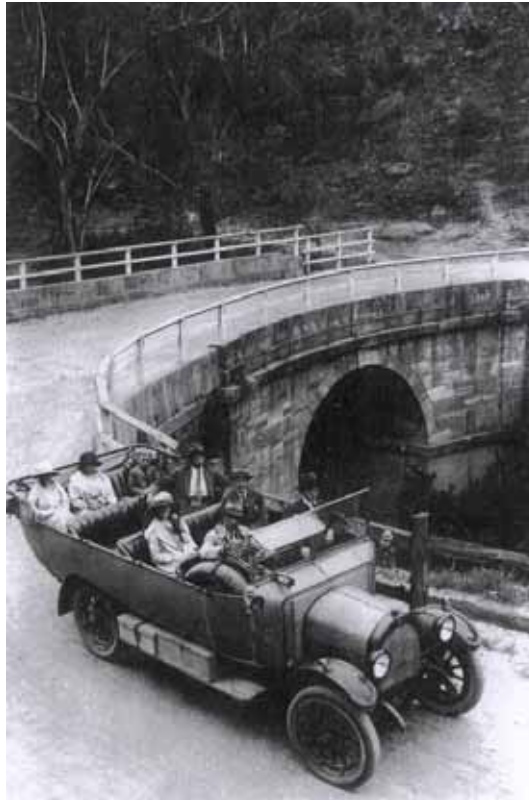
Figure 19
Lennox Bridge from the north-east, c. 1920.
Source: Mitchell Library, Small Picture File.

This rail was still in place in the days of the charabanc (Figure 19).

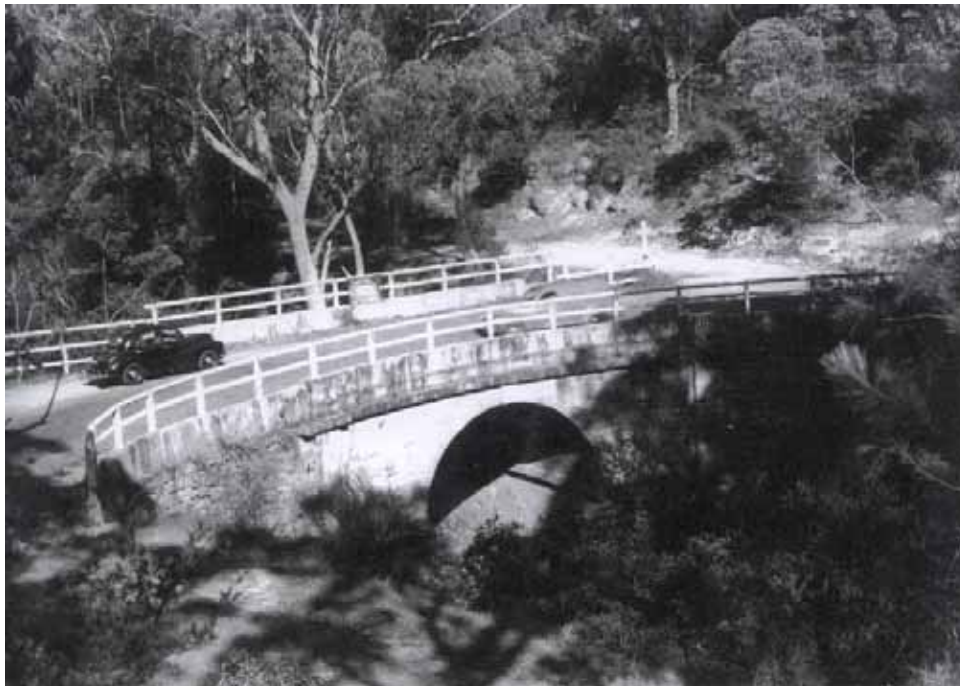
Figure 20
Lennox Bridge from the north-east, c. 1940.
Source: Mitchell Library, Small Picture File.

The rail continued to exist in the 1950s, to judge by the vehicle in an undated photograph (Figure 20) and by the 1957 photograph of the bridge by local historian Allan Searle (Figure 21).

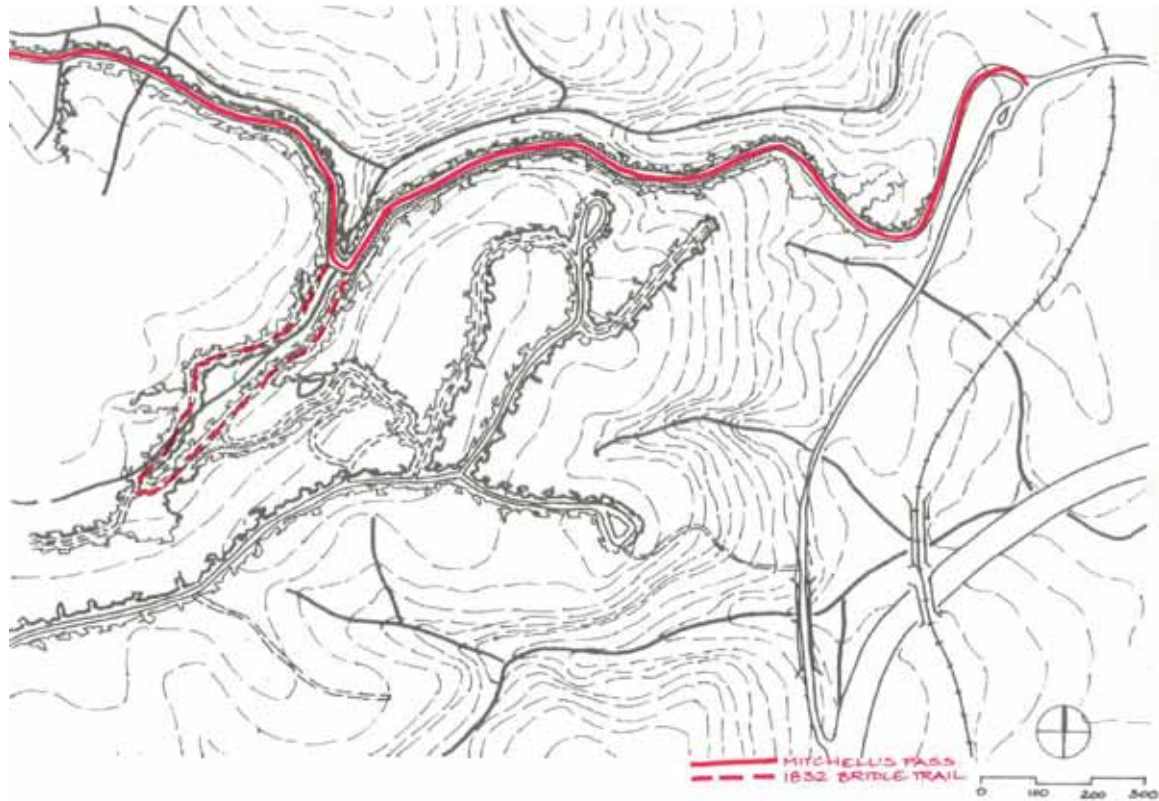
Figure 24
Site Plan showing location of Mitchell's Pass and 1832 bridle trail

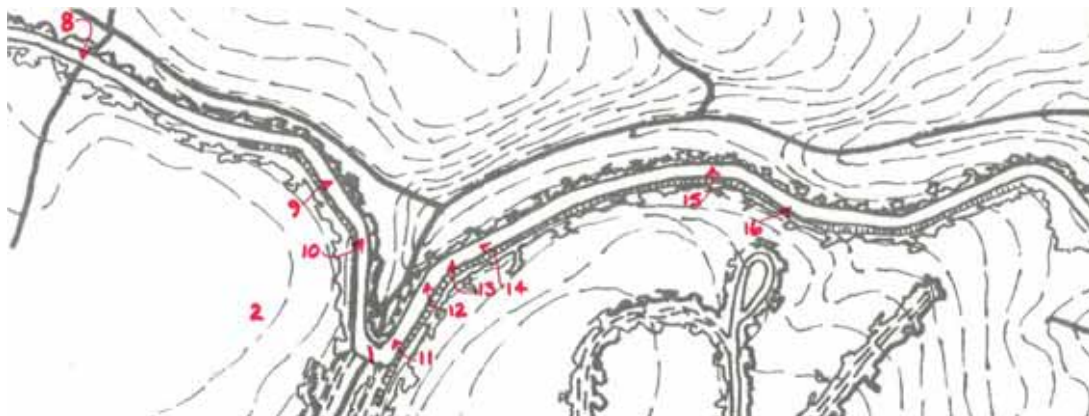
Figure 25
Detailed site plan showing site features along and near Mitchell's Pass

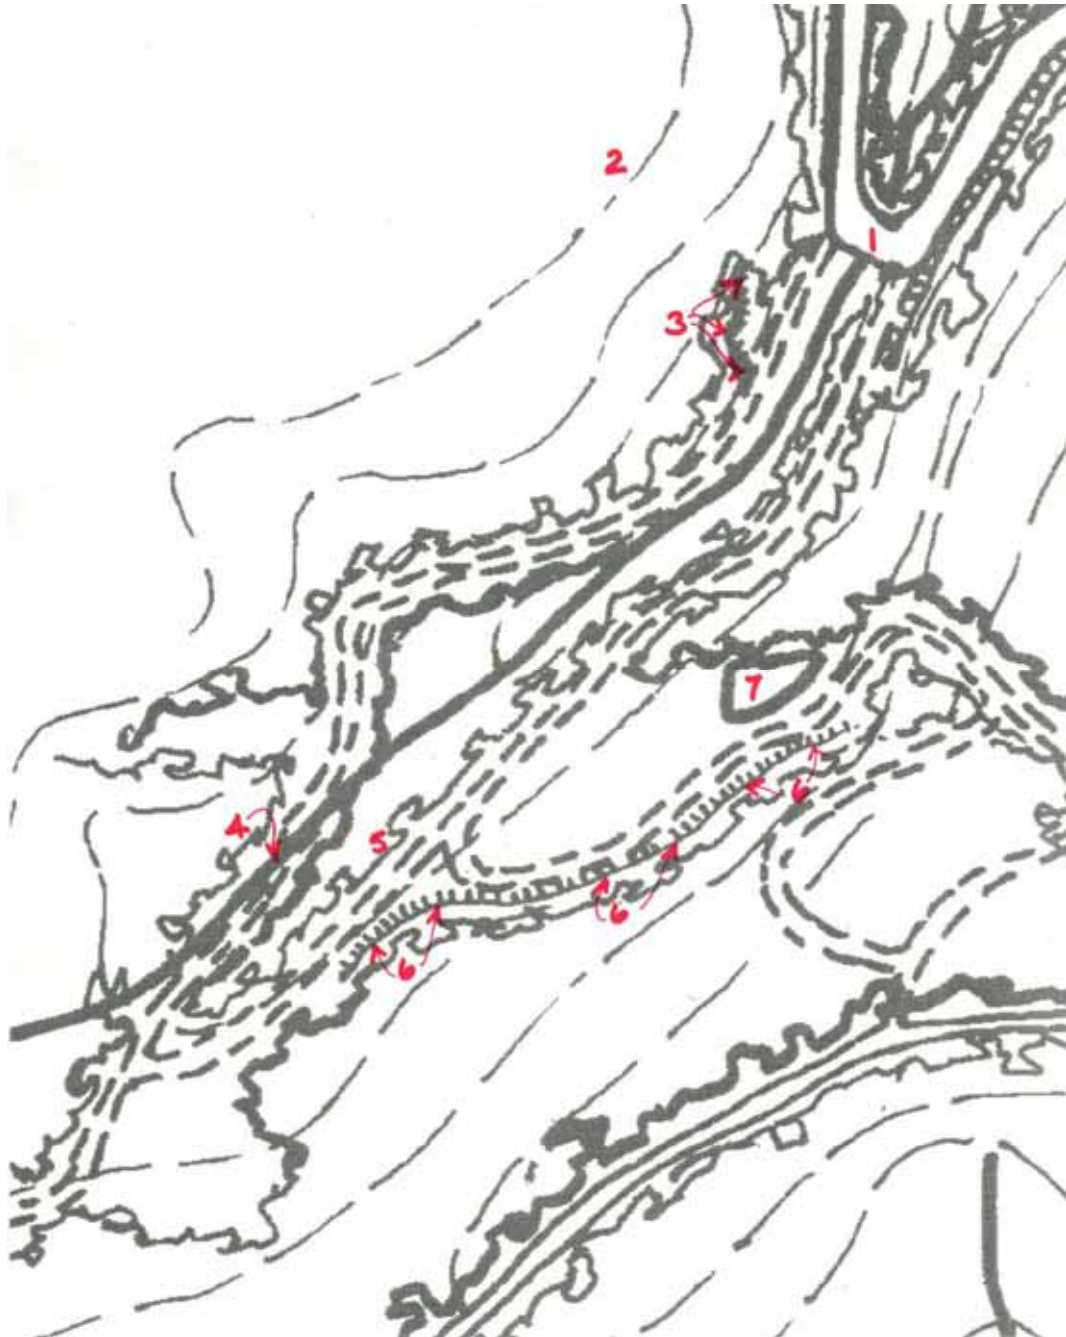
Figure 26
Detailed site plan showing site features along and near the 1832 bridle trail

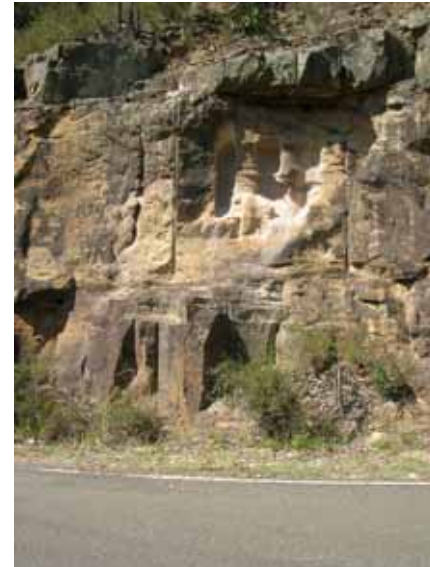
Figure 28
Mitchell's Pass showing area of erosion in rock cutting. Drill holes from the excavation of the escarpment to create the pass can be seen either side of the eroded area.

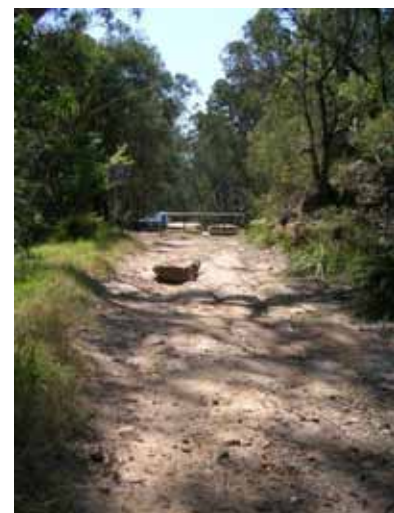
Figure 29
East track of bridle trail from south

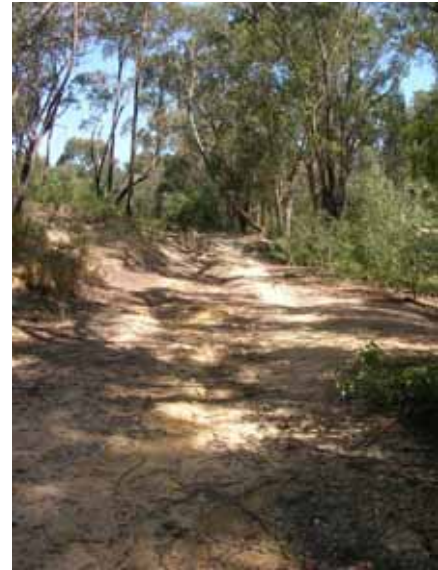
On the east side close to Lennox Bridge, the cutting into the side of Lapstone Hill extends south of the bridge adjacent to the track for a short distance.

Figure 30
East track of bridle trail from north

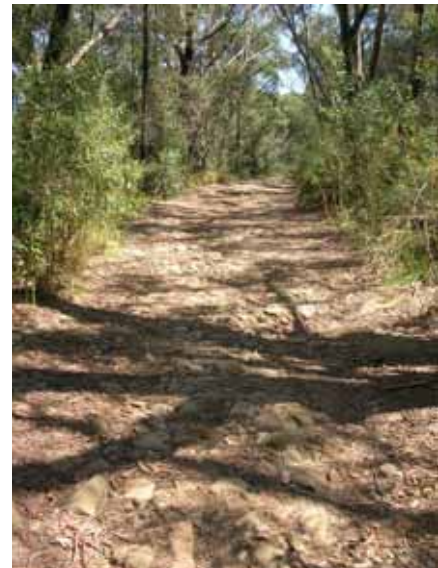
Figure 31
West track of bridle trail showing area of macadam construction.

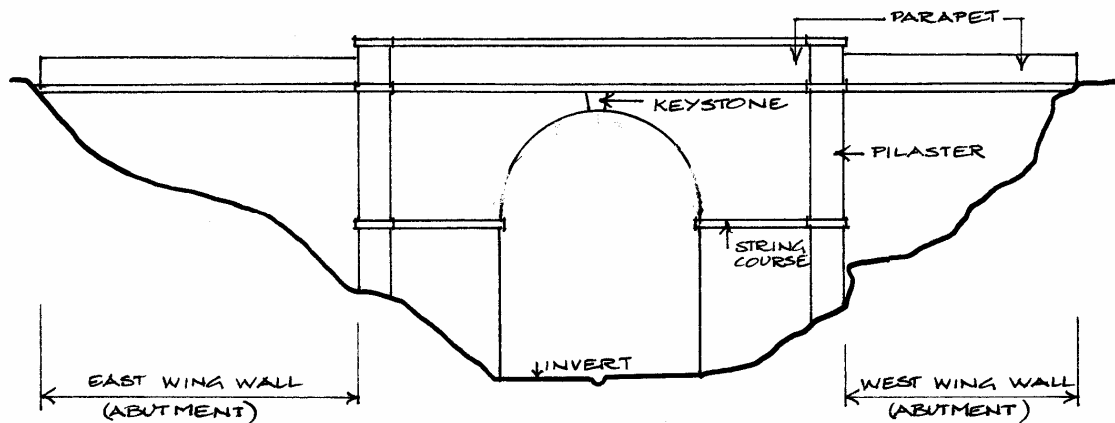
Figure 32

The following diagram indicates the terminology of the components of the bridge. These terms are used in the following description as well as in the Structural Report at Appendix 4.

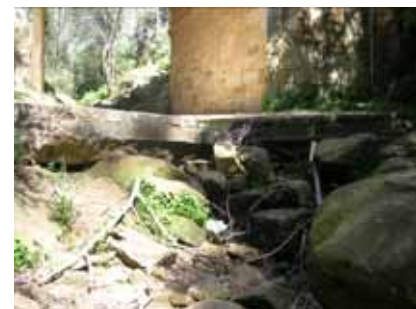
Figure 35

The wings of the bridge are constructed of random coursed sandstone. At the base of the bridge, and for approximately four metres to the north and south, the base of the creek has been paved with concrete and flagged with sandstone, probably as part of the 1970s work to the bridge. A semi-circular concrete drainage channel runs through the middle of the flagging.

View from north showing concrete at base of bridge with sandstone flagging

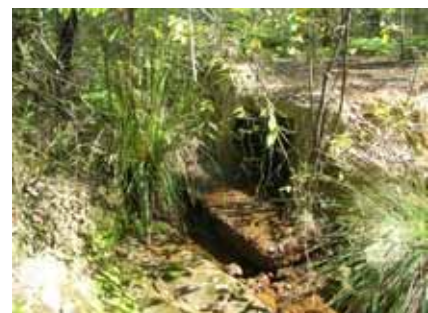
The west arm of the 1832 bridle trail crosses Brookside Creek with a retaining wall and culvert. The retaining wall is constructed of roughly coursed sandstone, possibly rebuilt when the present concrete culvert was installed. The concrete pipe culvert appears to date from the mid twentieth century.

The retaining wall has been crudely rebuilt. Parts of the wall to the north have collapsed.

Figure 38
Culvert on Brookside Creek

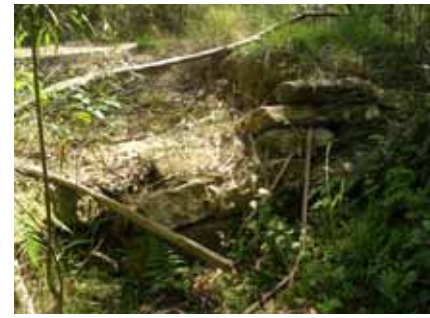
Figure 39
Retaining wall south of the culvert outlet.

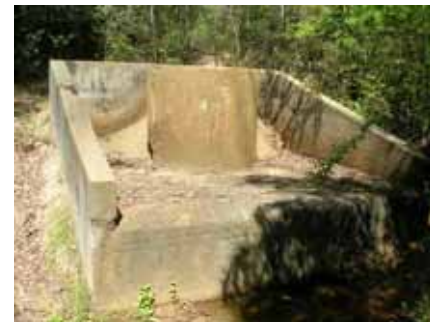
Figure 40
Energy dissipator

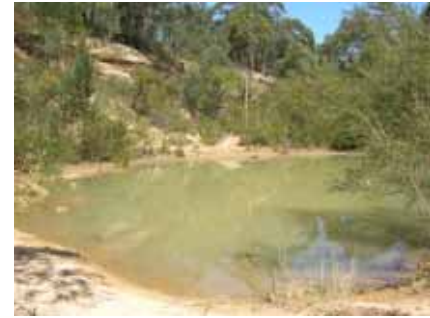
Figure 43
Sedimentation pond from northeast

A sedimentation pond is located to the north of the quarry, and east of the 1832 bridle trail. It is probably a late twentieth century feature, intended to allow silt and other runoff to collect and settle in a pond rather than affecting the water quality of the stream below.

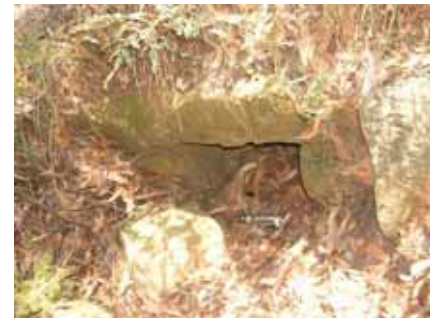
Figure 44
The intake of culvert 7 from south side

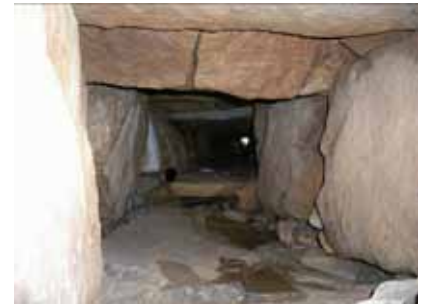
Figure 45
Structure of stone culvert below road surface
Photo: Simon Wiltshier, Hughes Trueman Pty Ltd 12 September 2007

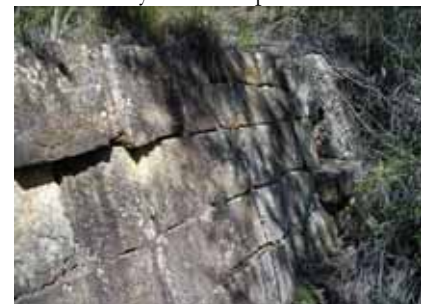
Figure 46
North face of culvert 6
Photo: Simon Wiltshier, Hughes Trueman Pty Ltd 12 September 2007

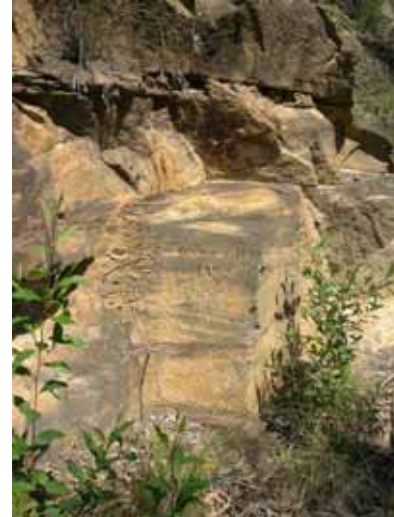
Figure 47
Milestone from east

The west face of the milestone has been damaged, obscuring the carving of SYDNEY XXXVII.

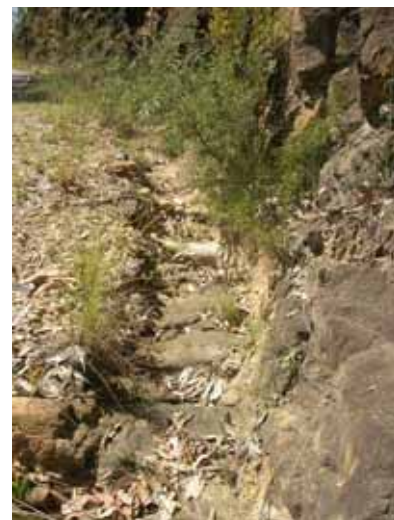
Figure 48
Drainage at base of rock cutting

Other areas of drains in the vicinity of the culverts east of Lennox Bridge appear to be largely silted up.

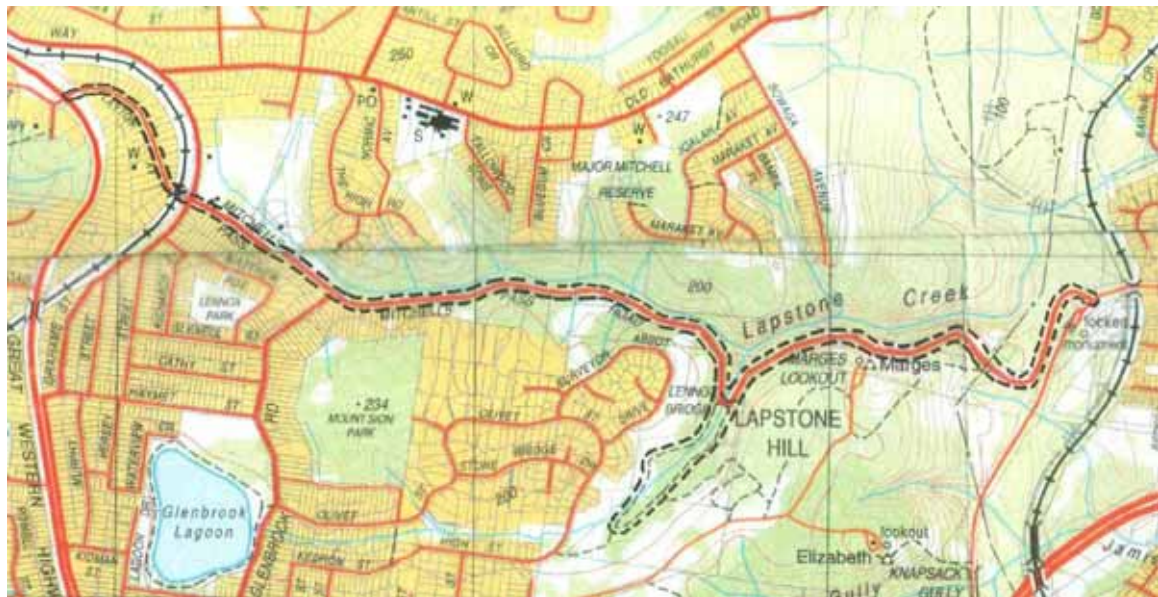
Figure 49

Mitchell's Pass Historic Precinct includes the roadway and associated structure of Mitchell's Pass, Lennox Bridge, the 1832 Bridle Trail and the small quarry. The extent of the place should be as indicated in the map at Figure 49.

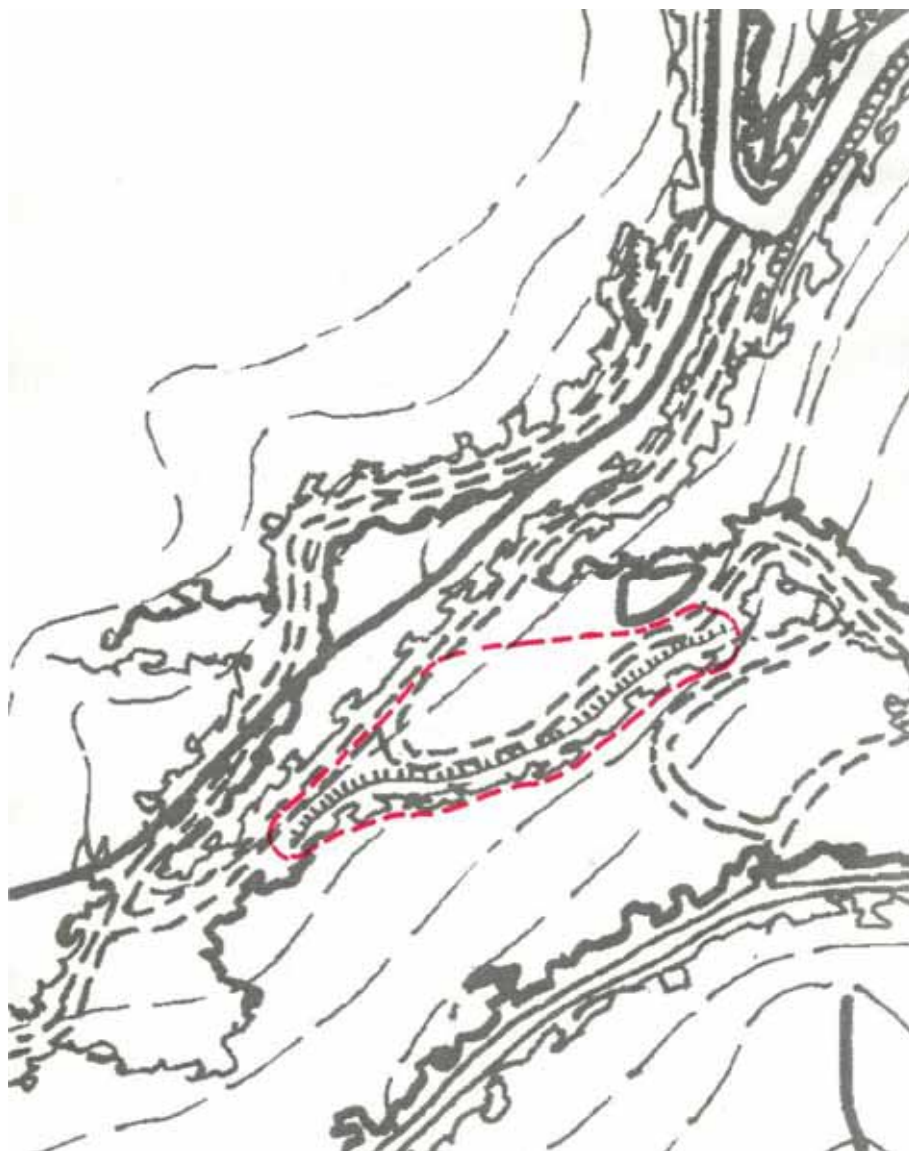
Figure 50
Curtilage of Brookside Creek Quarry (shown by dotted red line).

The quarry on the east side of the 1832 bridle trail should be known as Brookside Creek Quarry. The extent of Brookside Creek Quarry should be as indicated on the map at Figure 50.
